Protecting Railway Workers with an Electronic Overlay – a Demonstration

Protecting Railway Workers With an Electronic Overlay

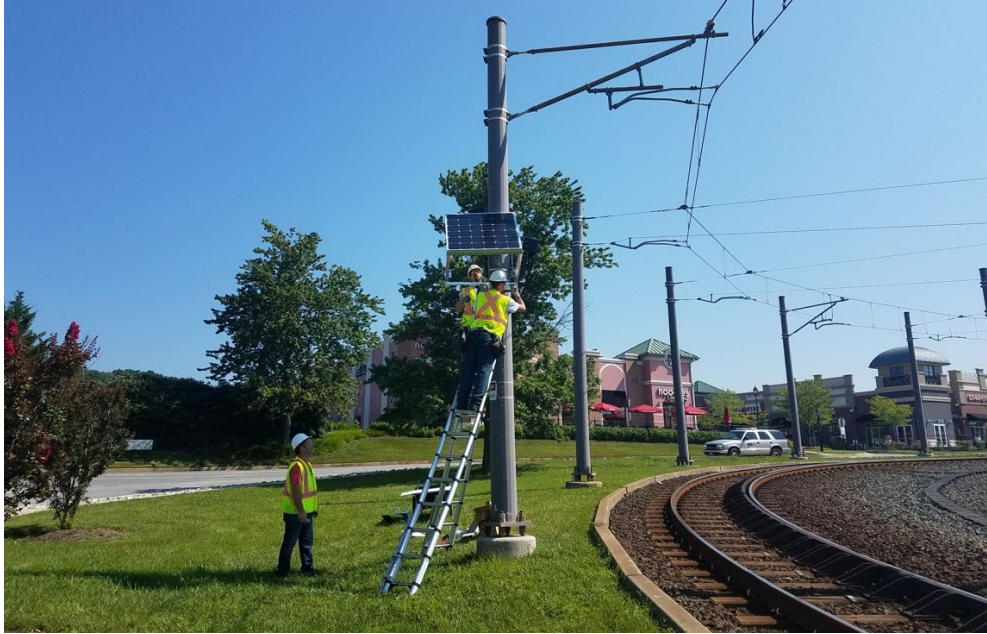
Figure 1: Installation of fixed ZoneGuard™ eRWP system on MTA Baltimore Light Rail Line.

Workers are outfitted with wearable devices that are connected to the ZoneGuard™ network and provide the system with updated worker location information. Each TDM and TAM is configured with a customer and location specific track profile, which includes the Maximum Allowable Speed of every track segment and a configurable alert time for when trains are approaching connected on-track workers. Alerts are configured to a minimum of 15 seconds to meet federal regulations but can be configured to provide greater warning times to meet customer specific rules or to increase the overall safety of the worker.

As trains and workers are detected, the system continuously monitors their locations and calculates intercept times between trains and connected workers in order to generate alerts at the configured time. This setup allows for workers and trains to receive alerts when trains are approaching workers despite track curves, tunnels, bridges, and when workers are working in multiple track territories.

The ZoneGuard™ fixed system provides 24/7 train tracking capability and is online ready to be used by any number of roadway workers, at any time, with no configuration or setup required. Roadway workers simply need to enter within radio range of the outfitted track alignment, connect to the ZoneGuard™ network, and will begin receiving alerts for all approaching on-track vehicles that are within a specific time of arrival to roadway workers, based on customer specific On-Track Protection rules.

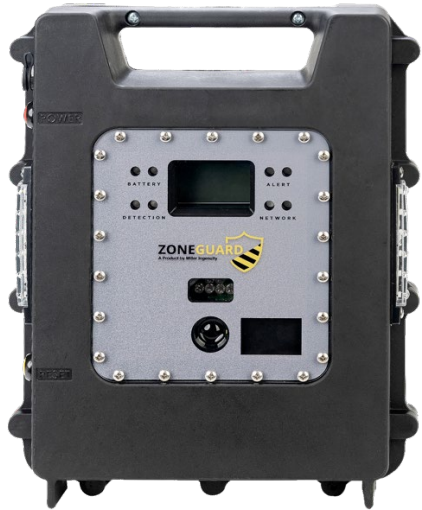
Figure 2: Portable ZoneGuard™ eRWP TDM

The portable eRWP kit is used as a standalone system and does not rely on any outside on-board or signaling systems in order to operate. The train detection modules define the outermost limits of the detection and alerting zone and are temporarily placed at the limits of a work zone, which is typically defined by a customer's sight-distance rules for watchman or are placed alongside approach and stop boards. TAMs are placed in between the outermost TDMs to act as radio network repeaters for TDMs and workers that are connected to the network through their wearable devices. As an additional alert to workers, TAMs also include a siren and bright side LED warning lights that are enabled when a train detection alert has been generated by TDMs.

The TDMs that are placed at the outermost limits of the temporary work zone will detect approaching on-track vehicles as they reach TDM locations and will generate alerts to all worker wearables and train alert modules that are in use.

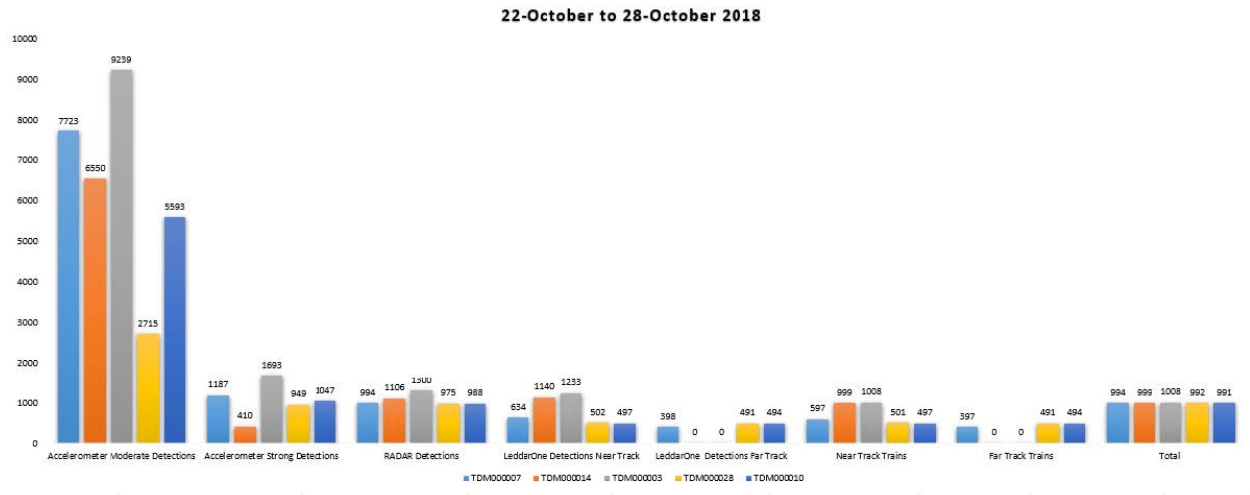
Figure 5. TDM and TAM detection data for October 22-28, 2018.

Sample Detection Results: All sensors have the same settings with the exception of sensing distance, which is set based on the distance each detector is installed relative to the track(s) it is monitoring. Despite this fact, some detectors have a radar that is sensing far more objects than its neighbors and some detectors have a LIDAR that is sensing far more objects than its neighbors. This tells us that each unique location where a detector is installed has differing environments and surroundings that cause different types of sensors to detect at different rates from one location to another.

In this data, if we were to use only one type of sensor in our system to detect trains and generate alerts, we would be extremely inconsistent. Using only one type of sensor to detect trains would cause a system to have high number of false alerts, meaning workers would become complacent with the system and begin ignoring alerts. By using an algorithm that uses multiple types of sensors, and not just multiple sensors, we are able to virtually eliminate false detections and/or alerts and missed detections.

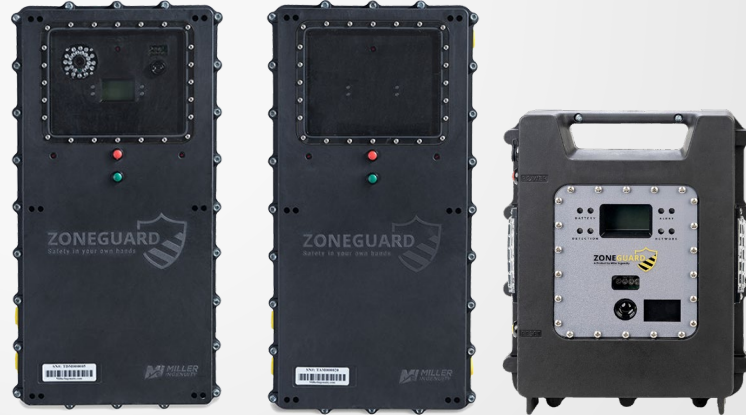
- Train Detection Modules (TDMs) & Train Alert Modules (TAMs)

ZoneGuard™, Miller Ingenuity’s eRWP system, is comprised of Train Detection Modules (TDMs), Train Alert Modules (TAMs), and worker wearable devices. The system can be used portably, or it can be permanently installed. ZoneGuard™ uses a unique combination of redundant sensor technologies to capture motion entering a work zone. The LIDAR, radar, accelerometer, and infrared cameras work together to ensure that a track vehicle will be detected consistently and accurately every time and in all conditions.

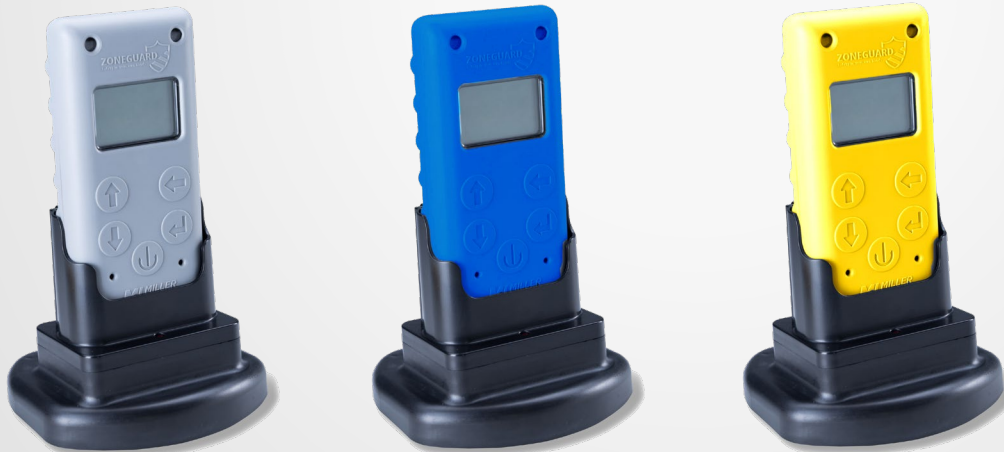
- Worker Wearable Devices

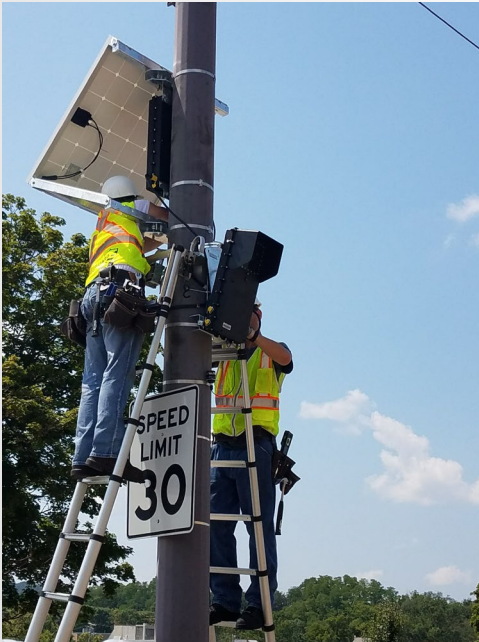
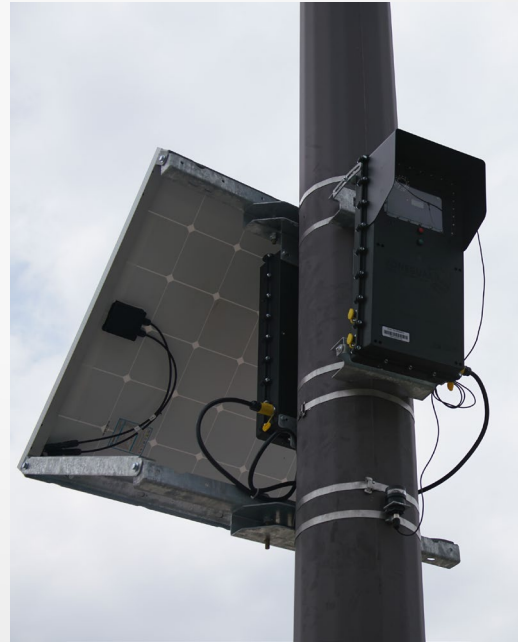
- ZoneGuard Fixed System

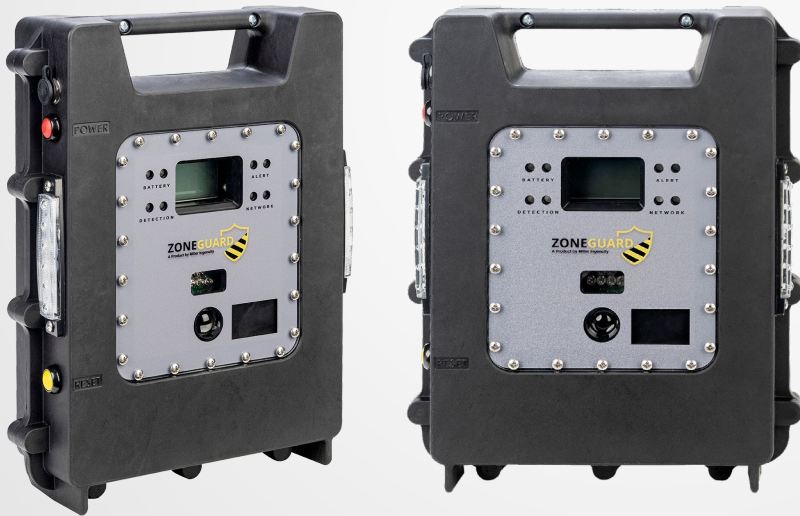
- ZoneGuard Portable System

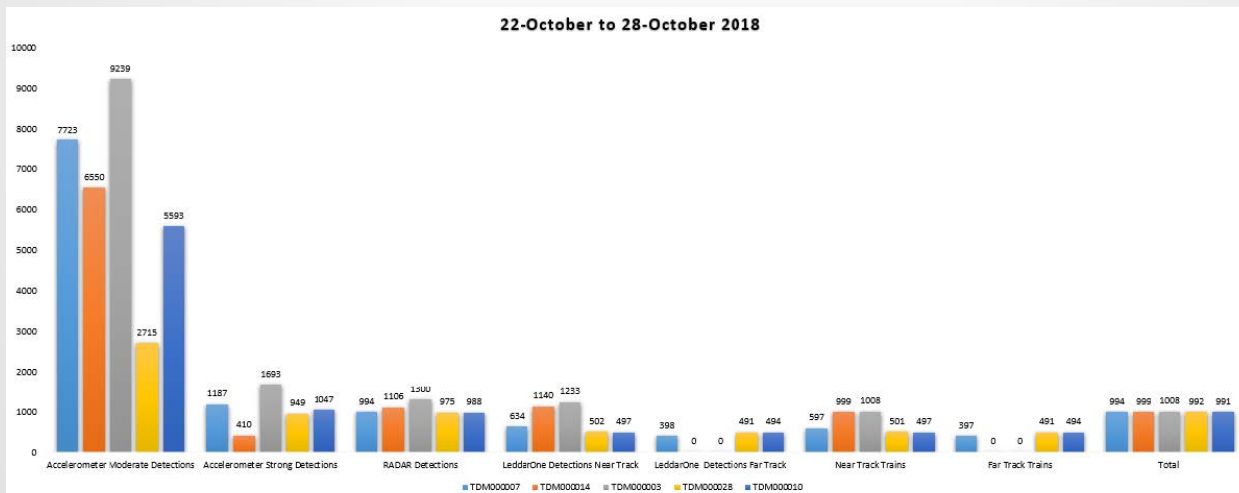
TDM/TAM ID	10-22-2018 to 10-28-2018							
	Individual Sensors Detection				Application Detections			
	Accelerometer Moderate Detections	Accelerometer Strong Detections	RADAR Detections	LeeddarOne Detections Near Track	LeeddarOne Detections Far Track	Near Track Trains	Far Track Trains	Total
TDM000007	7723	1187	994	634	398	597	397	994
TDM000014	6550	410	1106	1140	0	999	0	999
TDM000003	9239	1693	1300	1233	0	1008	0	1008
TDM000028	2715	949	975	502	491	501	491	992
TDM000010	5593	1047	988	497	494	497	494	991
